CHAPTER 7: STORMWATER

Eastern Shore Hazard Mitigation Plan 2021

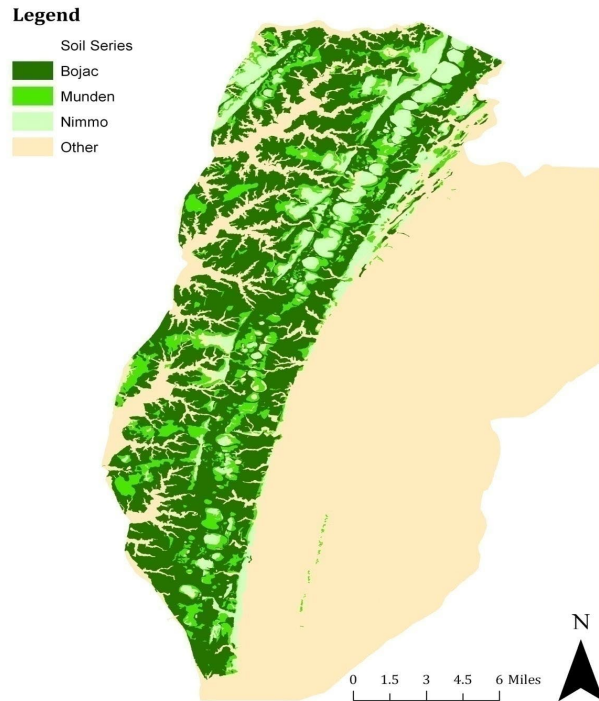
Figure 3: Northampton County Soils Map showing the distribution of the three predominant soil types

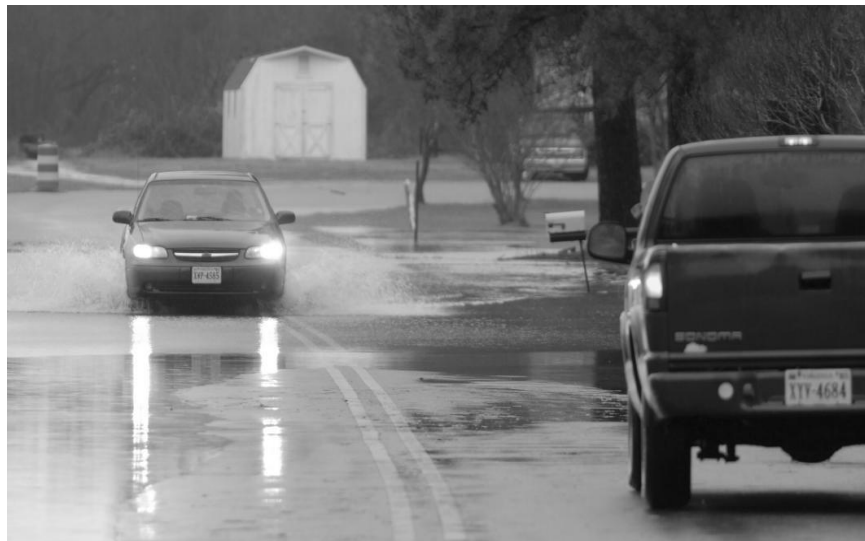
Figure 4: Common scene of flooded roadways following intense rainfall on the Eastern Shore. Photo by Jay Diem, Eastern Shore News.

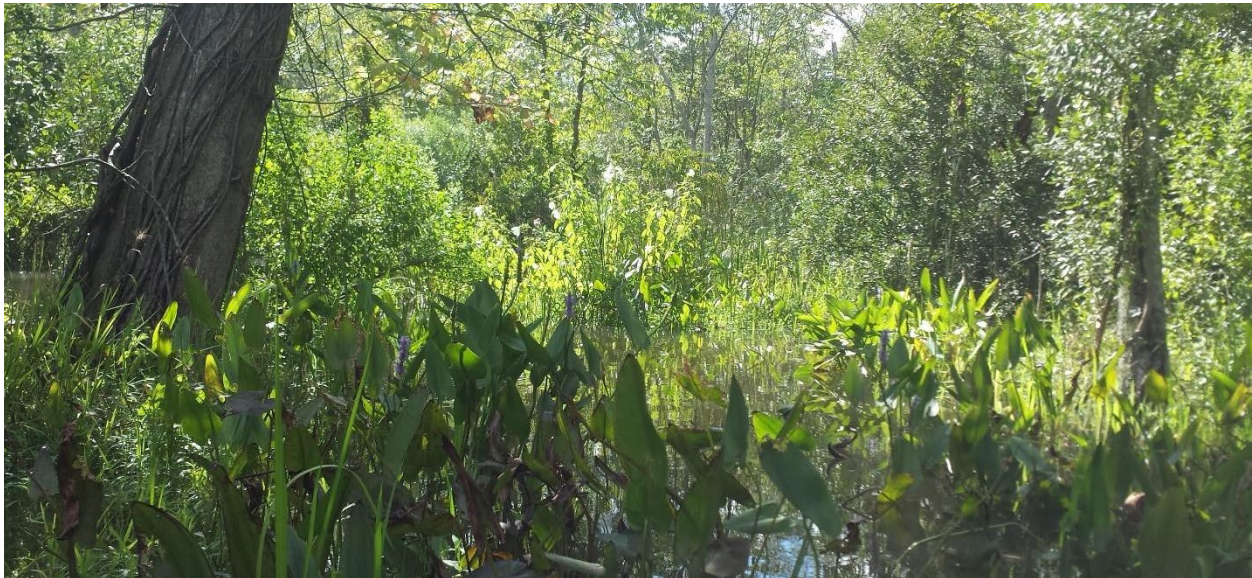
Figure 5: One of the ecosystem services of fresh water wetlands is flood mitigation. Shifting habitats can alter the ability of an area to help absorb flood waters. Photo By: Shannon Alexander

Changes to vegetation can also occur, and depending on the ecosystems' ability to migrate and their ability to retain flood waters, the impacts on stormwater flooding will vary greatly. An example of natural flood mitigation through vegetation can be seen in Figure 5. Overall, it is predicted that there will be a decrease in dry land (developed and undeveloped), irregularly flooded salt marsh, and other nontidal wetlands, but an increase in the expanse of regularly flooded and transitional salt marshes. Figure 6 reveals these changes, as shown by the Future Habitat application of the Coastal Resilience mapping tool. Vegetation serves as a stabilizing force for shorelines and a water retention resource on the shoreline and inland, and thus a loss of vegetation increases inland areas' susceptibility to flooding.

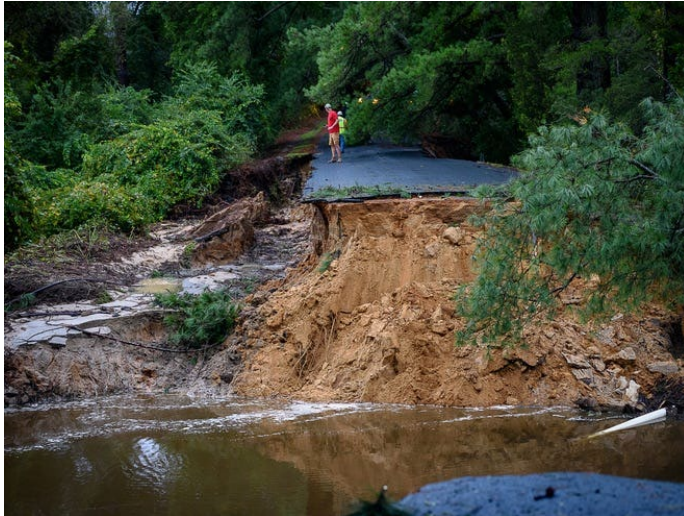
Hillsborough neighborhood in Belle Haven Monday Morning September 10, 2018. *Phillip Spohn* Photo Credit

Flash flooding from stormwater can be quite hazardous to humans. Since conditions develop rapidly, people can become trapped before even realizing they are in danger. In September 2018, heavy rains related to Hurricane Florence washed away a portion of Hillsborough Drive in Belle Haven and closed several other roads in Accomack and Northampton Counties. Flooding like this creates safety hazards and takes time, money, and resources to repair.
