# CHAPTER 6: COASTAL FLOODING

Eastern Shore of Virginia Hazard Mitigation Plan 2021

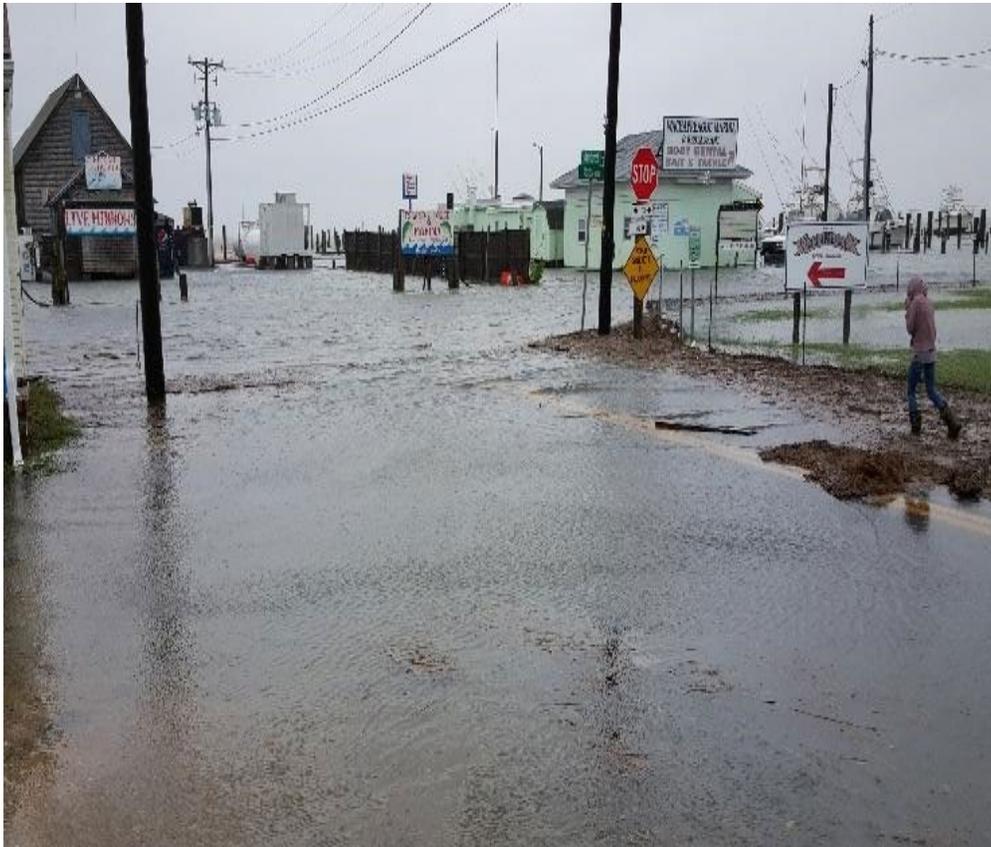
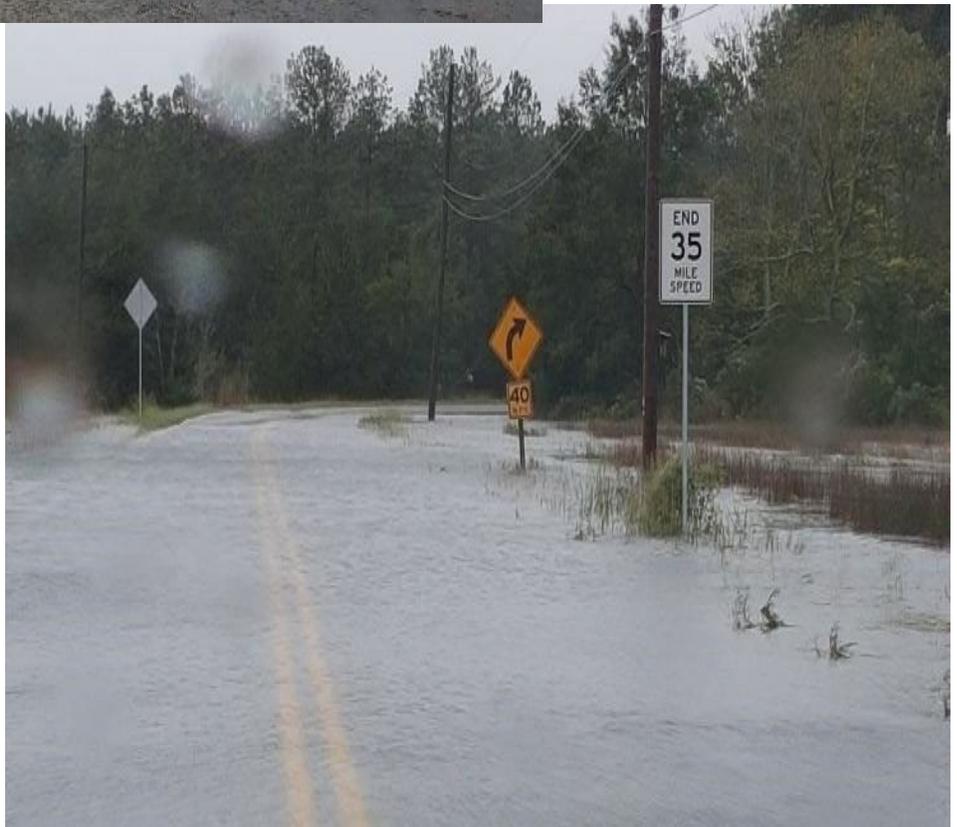
**Figure 1: Flooding on Atlantic Ave. (above) and Drummondtown Rd. (right), Oct. 2, 2015. Photo Credit: A-NPDC staff**
