CHAPTER 5: COASTAL EROSION

Eastern Shore Hazard Mitigation Plan 2021

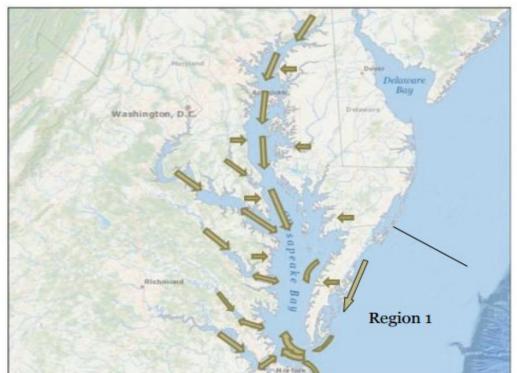
Figure 2: Net sediment transport pathways for Chesapeake Bay and Atlantic area off the Virginia Cost. Source: "North Atlantic Coast Comprehensive Study Report (USACE, 2015).

The general pattern of transport in the Eastern Shore area is southward along the Atlantic Coastline into the Chesapeake, and southward within the bay to the lower Chesapeake where it is deposited either in the bay or tributaries of lower bay rivers, as shown in Figure 2 (USACE, 2015).

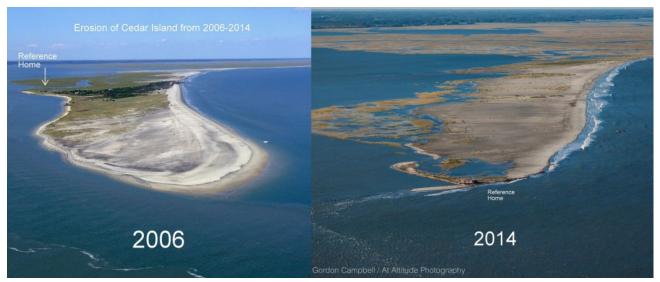
Figure 3: Changes to the southern end of Cedar Island, 2006-2014. Source: Gordon Campbell, At Altitude Photograph. Copyright protected, used with permission.

Sediment in this environment is moved by both longshore drift, which requires an adequate supply of sediment and "rollover," where high tides erode sand from the ocean side of the island and carry it toward the center or back side of the island as seen in Figures 4 and 5. Another factor of barrier island erosion is the interruption of the supply of sand by up-stream interventions such as jetties or groins. Storms are unable to remobilize this trapped sediment, and downstream islands erode as a result (USACE, 2015).

Sections of the barrier islands are changing rapidly, with segments of islands disappearing and moving into the back barrier channels and marshes. This is especially true for areas adjacent to active inlets and as shown in Figure 4. The home that is the subject of the photos no longer exists.

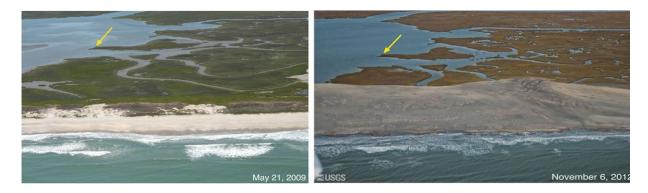
Figure 5: Aerial photographs of a section of Assateauge Island before and after Hurricane Sandy. Photo Credit: USGS

Because the Eastern Shore barrier islands are largely in their natural states and without erosion control mechanisms, the process of rollover is readily observed. In Figure 5, images of a section of Assateague Island, taken before and after Hurricane Sandy, illustrate how waves washing over the island carried sand toward the mainland. This phenomenon provides critical width for islands and establishes a back-barrier platform which the island can continue to roll onto, thereby increasing the long-term viability of the island.

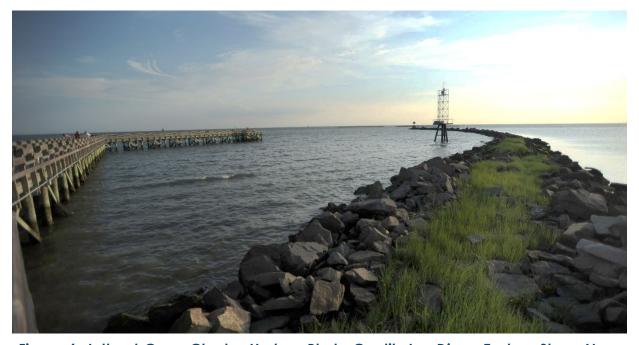
Figure 4: Jetty at Cape Charles Harbor. Photo Credit: Jay Diem, Eastern Shore News. Used with permission.

Groins and jetties are engineered structures placed perpendicular to the shoreline to interrupt longshore drift. Both kinds of structures extend out into the water, but jetties are generally used to protect inlets and harbor entrances (Figure 6), while groins can be used to protect any stretch of shoreline.

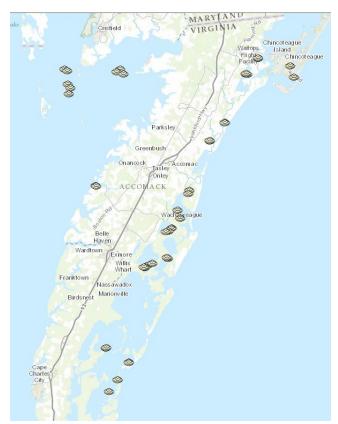
Figure 11: Locations of Manually-Constructed Oyster Reefs in Waters off Virginia's Eastern Shore. Source: VCZMP

Oyster reefs can serve as natural breakwaters and, once established, continue to grow vertically over time with sea-level rise, improving their ability to resist storms and mitigate erosion. Figure 11 shows the locations of oyster reefs that have been installed for long-term water quality and coastal resilience benefits, and Figure 12 is a photograph of an oyster reef under construction. Since oyster reefs are limited in elevation by the depth of the water column at a normal high tide, they provide excellent protection from relatively smaller waves and storm surge events; however, they can only provide minimal protection from wave action riding atop that is above average high tides or storm surge.
